Avid Electrical Services

Thermal Imaging Report

To: Mr A. Customer

Your Business Australia Pty Ltd

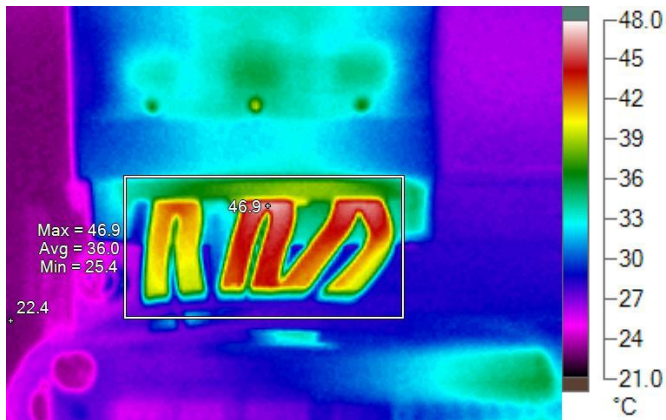
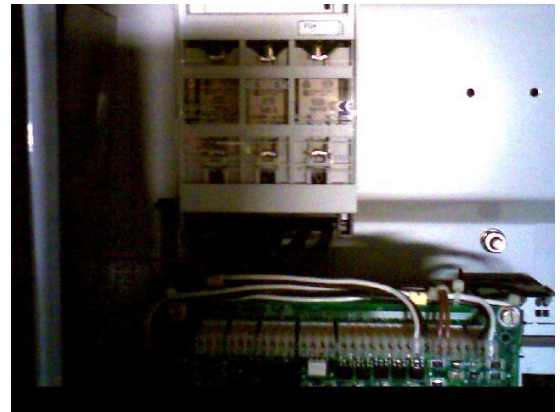
6	IR000232.is2	Serious Fault - High

A/C Control Panel. 3 - Phase Fuse Cartridge

Termination Fault – Load Side.

Fault Rating	Serious
Recommendation or Comment	Requires repair in 2 to 3 weeks

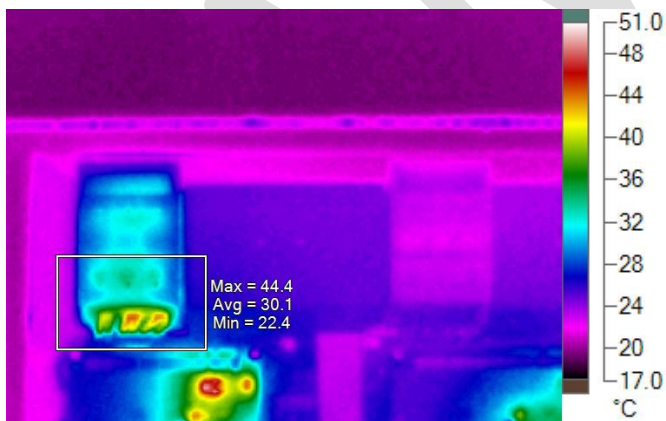
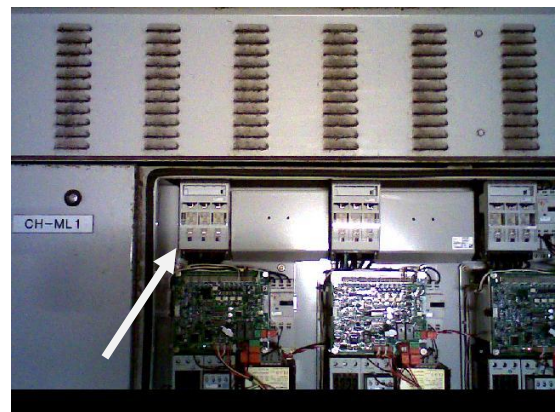
IR000232.is2

A/C Control Panel. 3 - Phase Fuse Cartridge Fault Detail

Name	Avg	Min	Max	Emissivity	St. Dev.
A0	36.0°C	25.4°C	46.9°C	0.97	5.75
